Manhole Inspection Summary

Manhole # S17G__014MH

Insp Date: **10/4/07 2:05 PM**

Location Address: **2300 VINE-FAYETTE**

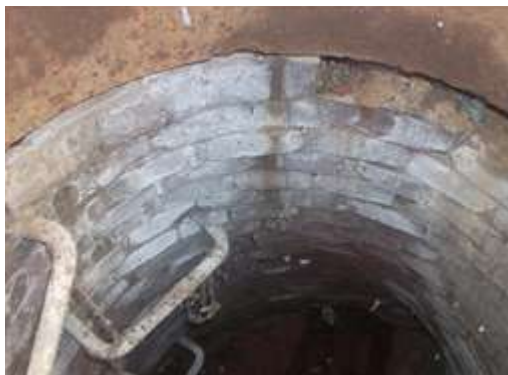
Defect 2

Infiltration: ☐ None ☒ **Joint** ☐ Cracks ☐ Mortar ☐ Roots ☐ Wall

CORBEL INFILTRATION

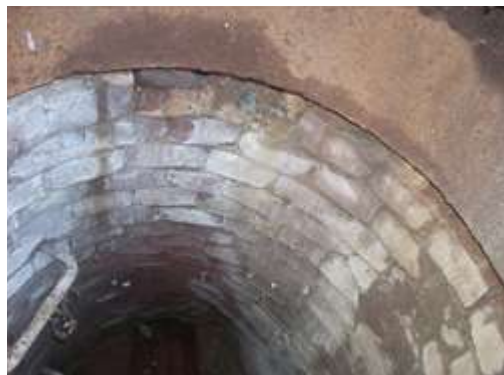
Defect 1

Condition: ☐ Sound ☐ Cracked ☐ Root Intrusion ☐ Loose Brick ☒ **Deteriorated**

DETERIOATED CORBEL

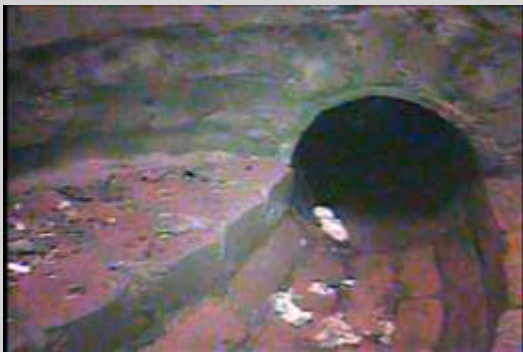
12 O'Clock Outflow

8 in. Circular Gravity Sewer
Pipe Out @ 12 O'Clock

Pipe Height: **8.4** (in.) Rod and Bar (Angled)
Pipe Material: **Clay** ☐ Pipe Lined
Invert Depth: **7.09** (ft.) Flow Characteristics: **None**
Deposits: ☒ None ☐ Mud ☐ Sludge ☐ Debris ☐ Grease
Silt Depth: (in.) Deposits Extent:
Infiltration: **None** Pipe Seal Cond: **Sound**

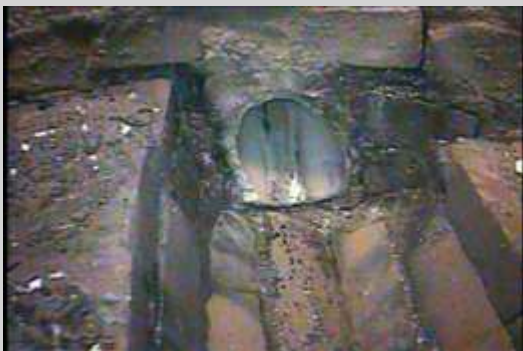
8 O'Clock Inflow

6 in. Circular Gravity Sewer
Pipe In @ 8 O'Clock

Pipe Height: **6** (in.) Rod and Bar (Angled)
Pipe Material: **PVC** ☐ Pipe Lined
Invert Depth: **6.61** (ft.) Flow Characteristics: **None**
Deposits: ☒ None ☐ Mud ☐ Sludge ☐ Debris ☐ Grease
Silt Depth: (in.) Deposits Extent:
Infiltration: **None** Pipe Seal Cond: **Broken**
